MEMORANDUM

To: Jamie Cox, Wairoa District Council
From: Angela Lane, Lowe Environmental Impact / Karen Akuhata (WDC)
Date: 11 September 2017
Subject: Task A2I2 Current Outfall Pipe Description

A2I2 Current Outfall Pipe Description

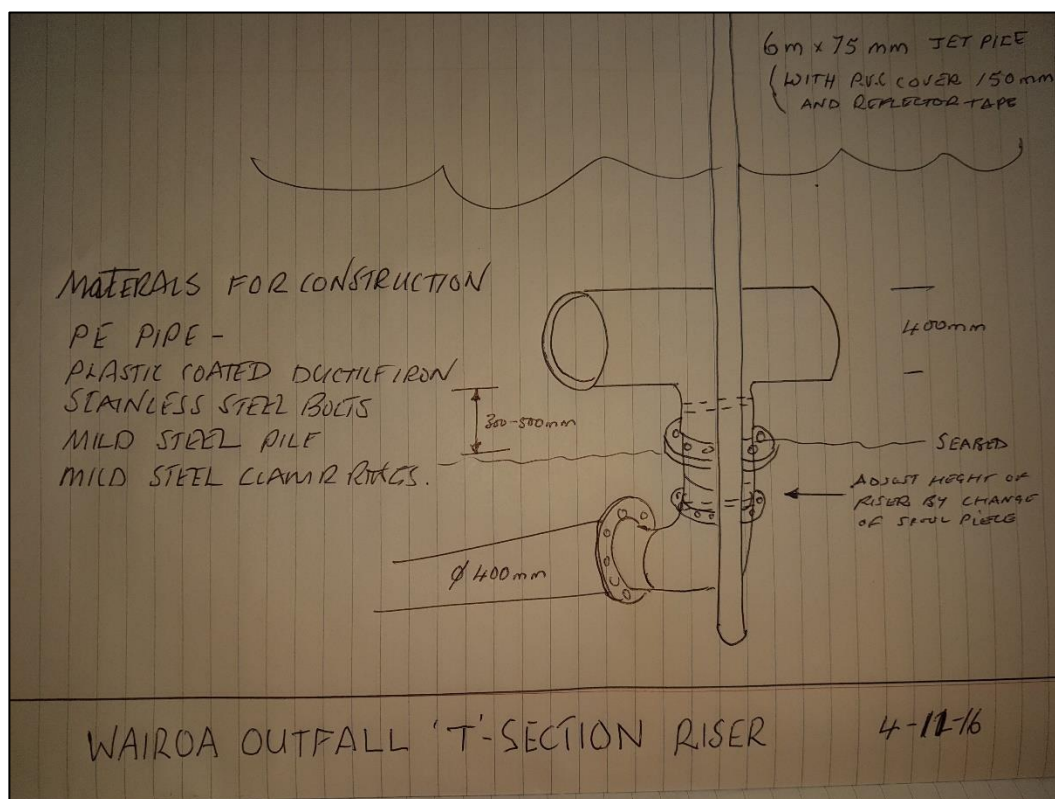
The outfall was uncovered with dredging and debris removal, but this was seen as a short-term solution with recommendations to install a stand pipe with a T junction to the current riverbed level (Figure 1), or to extend the pipeline into a deeper area of the river.

Figure 1: Description of the T-Section riser that was suggested to be installed to avoid overflows of the onshore surge chamber (source: WDC)

On 21 March 2017, a diffuser tee was installed, as per the recommendations and Figure 1 above, to prevent further issues with overflows and a backlog of discharging wastewater.

However, in April 2017 the diffuser T was removed as back pressure issues emerged. Although the diffuser T has been removed, further back pressure issues are still being experienced especially during high flows.
