# Wairoa Cyclone Gabrielle Review

Prepared for – Wairoa District Council

APRIL 4, 2024

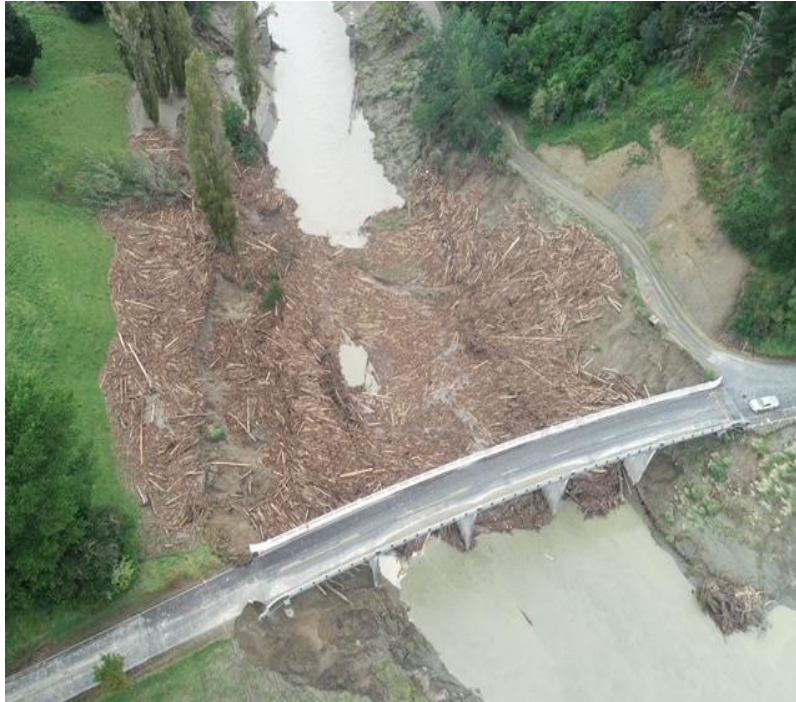
*Figure 7. Woody Debris Kotare Bridge, February 2023 mainly pine but not physically surveyed*

*There is clear evidence of woody debris, likely pine dominant, creating infrastructure damage – Kotare Bridge.*

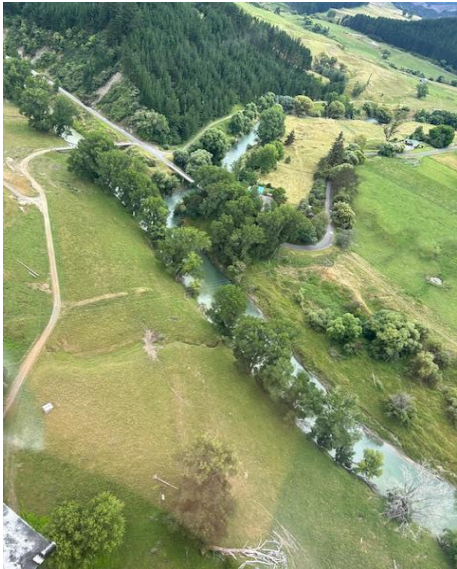
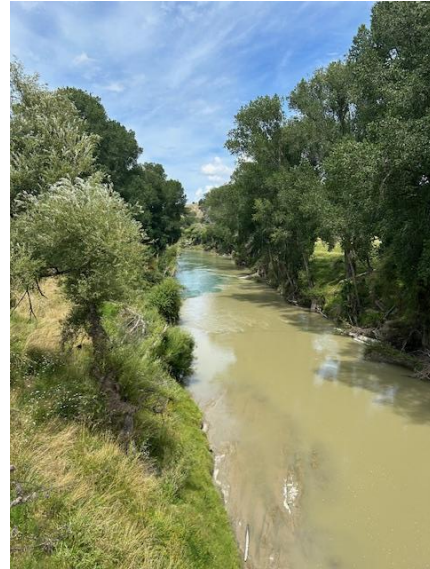
*Figures 8. & 9. Poplars Waikaretaheke Waiau Confluence*

As the major tributaries i.e., Waiau and Wairoa exit the foothills, and traverse the floodplain, the prevalence of very large poplars on and adjacent to the riverbanks is significant.

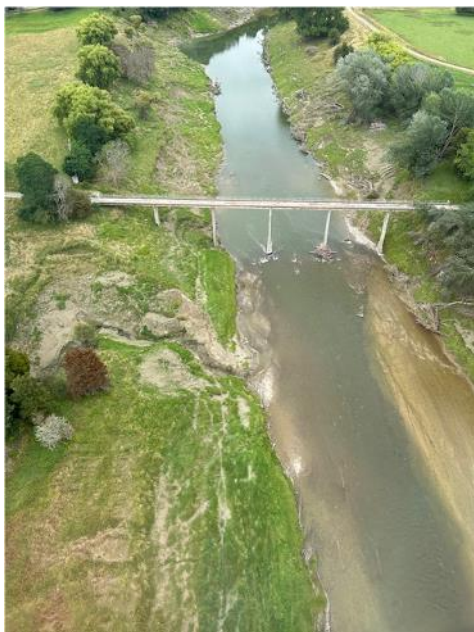
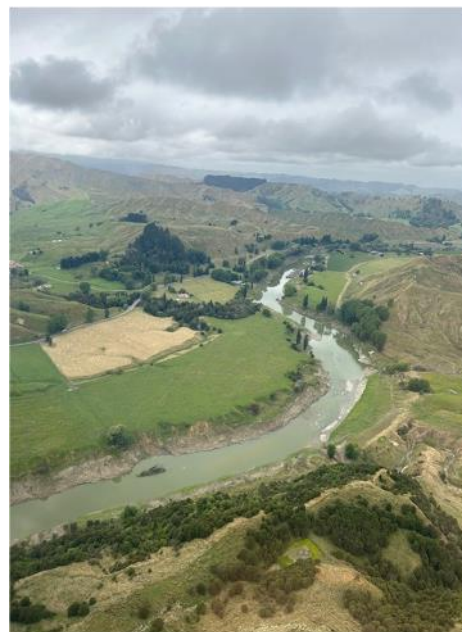
*Figures 10. & 11. Wairoa River post Gabrielle- significant bank modification*

Hangaroa, Wairoa and Mangapoike rivers with additional silt having originated from slip failure in the adjacent hill country, from both land that is farmed and has been afforested. Figures 10 and 11 on the Wairoa River show riverbanks that have been scoured of both silt and trees, whereas figures 8 and 9 on the Waiau show intact poplars and silt aggregation around the poplars. Figure 18 shows slip damage on both Farm and Forestland.

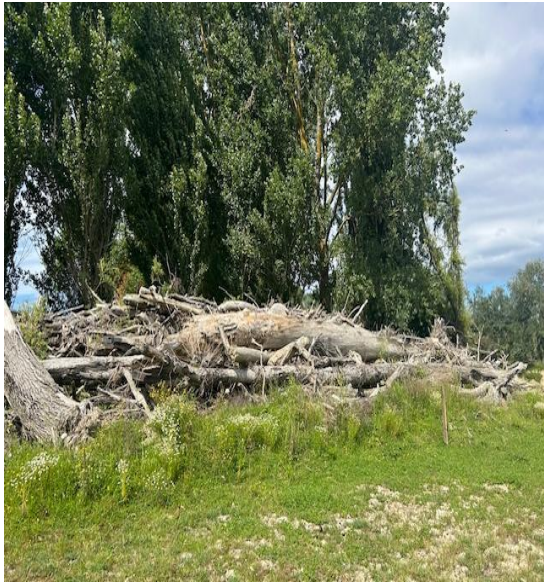
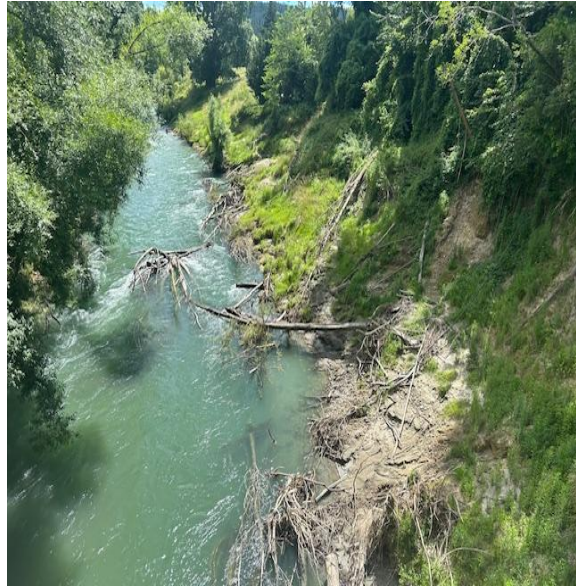
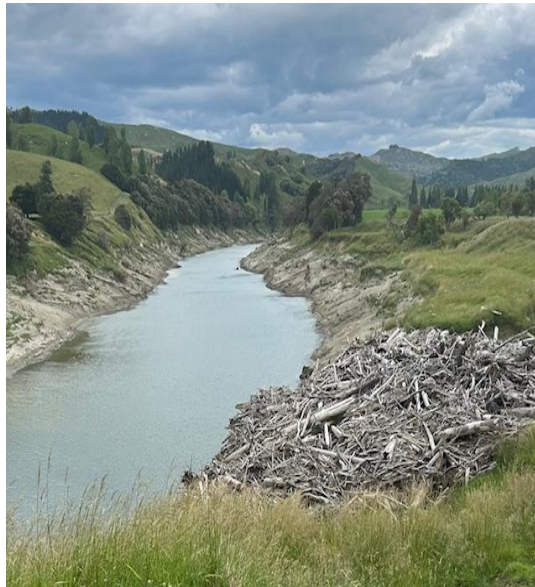
*Figures 12., 13. & 14. Poplar debris adjacent to Wairoa near rail bridge and Marumaru and in the Waikaretaheke*

Residents have noted that the larger material creating the debris dam on the rail bridge upstream of the township comprised a significant volume of large poplars in some case standing upright against the bridge. Further comment was made that upright poplars within the Wairoa mainstem upstream of the rail bridge toppled powerlines crossing the river. This position is anecdotally similar to that experienced in Cyclone Bola.

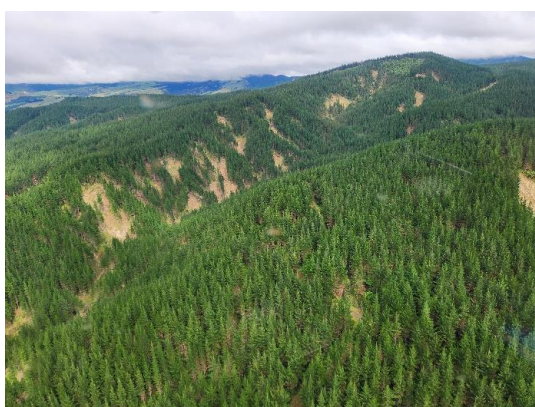
Figure 17. 'Mid slope failure Waikare Forest

Figure 18. Google Earth image of storm damaged forest & farmland between Mangapoike, Tiniroto roads

Damage in the Waikare Forest is significant and in particular involves ‘mid-slope failure’ and the loss of 10–12-year-old trees in their entirety.

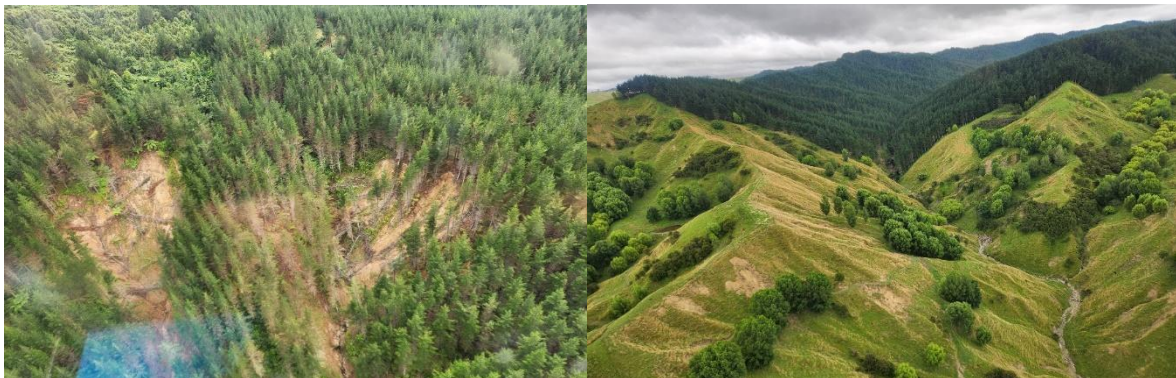
Figure 19. Windthrow - Forest near Ruakituri

Figure 20. Intact Forest/Farmland near Frasertown

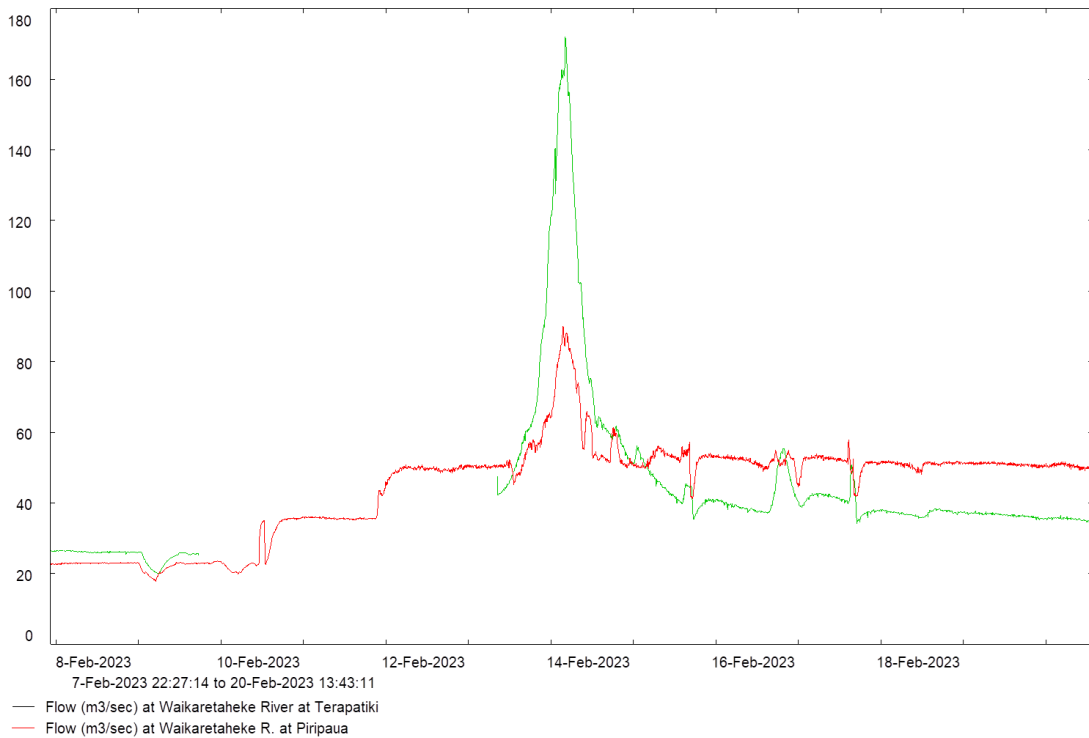
Having said this there was flooding of amenity assets around Lake Waikaremoana before, during and after Gabrielle, and localised flooding of farmland downstream of the scheme on the Waikaretaheke during Gabrielle and from high rainfall events shortly thereafter at levels not previously experienced according to local comment (Attachment 3). The peak flows observed at the Piripaua Bridge (Total Power Scheme Outflow) were high but not exceptional, occurring 8 times in the last 20 years. Whereas the flow record only 4 kms downstream from Piripaua at the Waikaretaheke at Terapatiki flow station shows the highest flows since records began at the site reaching 170 m<sup>3</sup>/s. This flow data points to extremely high intensity rainfall in a very localised area.

Figure 22. Hydrograph Waikaretaheke - Cyclone Gabrielle

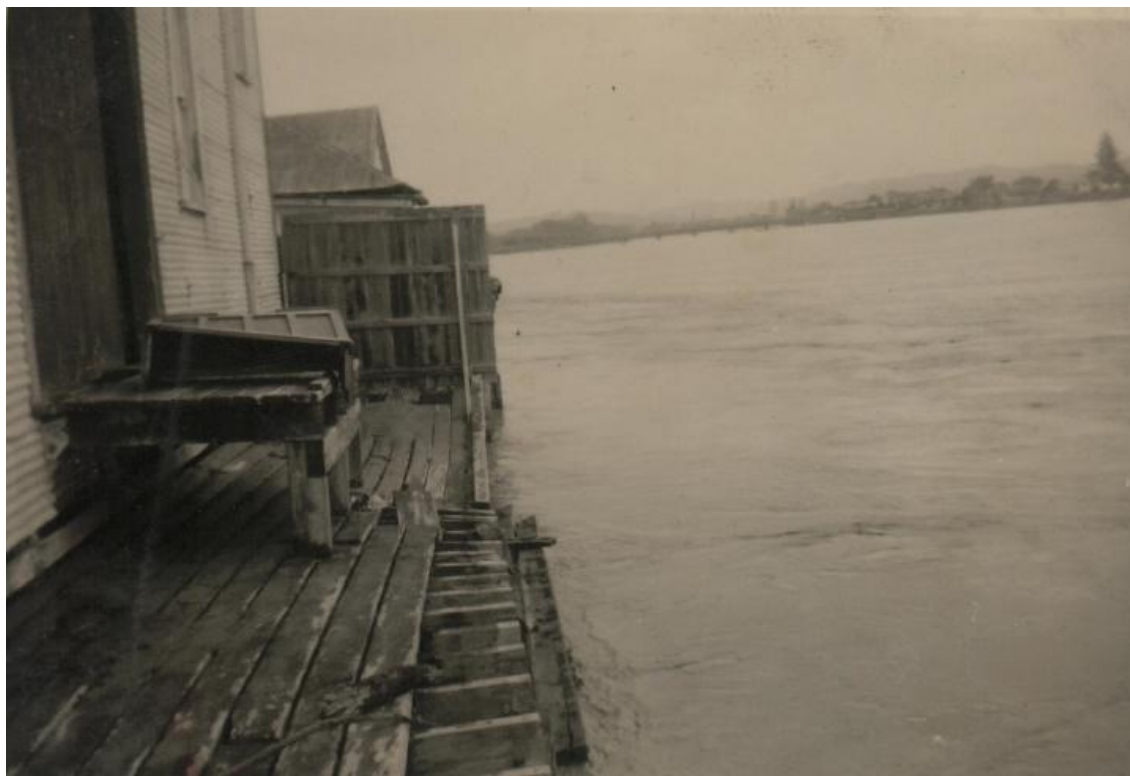
*Figure 23. North Clyde and Wairoa River 1948*

The 1948 storm was analysed in detail as part of HBRCs development of flood mitigation options for Wairoa through the late 1990's to early 2000's. The analysis undertaken by Gary Clode<sup>12</sup> in 1994 continues to provide an excellent baseline for understanding 'flood behaviour' and has been referenced in the work currently being undertaken by WSP on flood risk mitigation options for Wairoa. Because of this analysis, referenced in subsequent HBRC reports thereafter, the 1948 event scale with a peak flow rate of 8,200 cumecs was identified as a 1 in 100-year event by the Ministry of Works and Developments 1987 report titled SH38 Waiiau River Flooding. Noting however that there was an allowance for a wide margin of error in the flow estimate of plus/minus 35%. The most up to date preliminary estimates for a 1 in 100-year event now suggest a lower peak flow number of 6,700 cumecs in a 1 in 100-year event based on 'current climate conditions' versus the estimated 8,200 cumecs derived in 1994<sup>13</sup>. Post 1994, a flood model incorporating elements of this work and updated Lidar data was developed and reported in 2006 showing the extent of flood water forecast from a 1 in 100-year event (see figure 23).

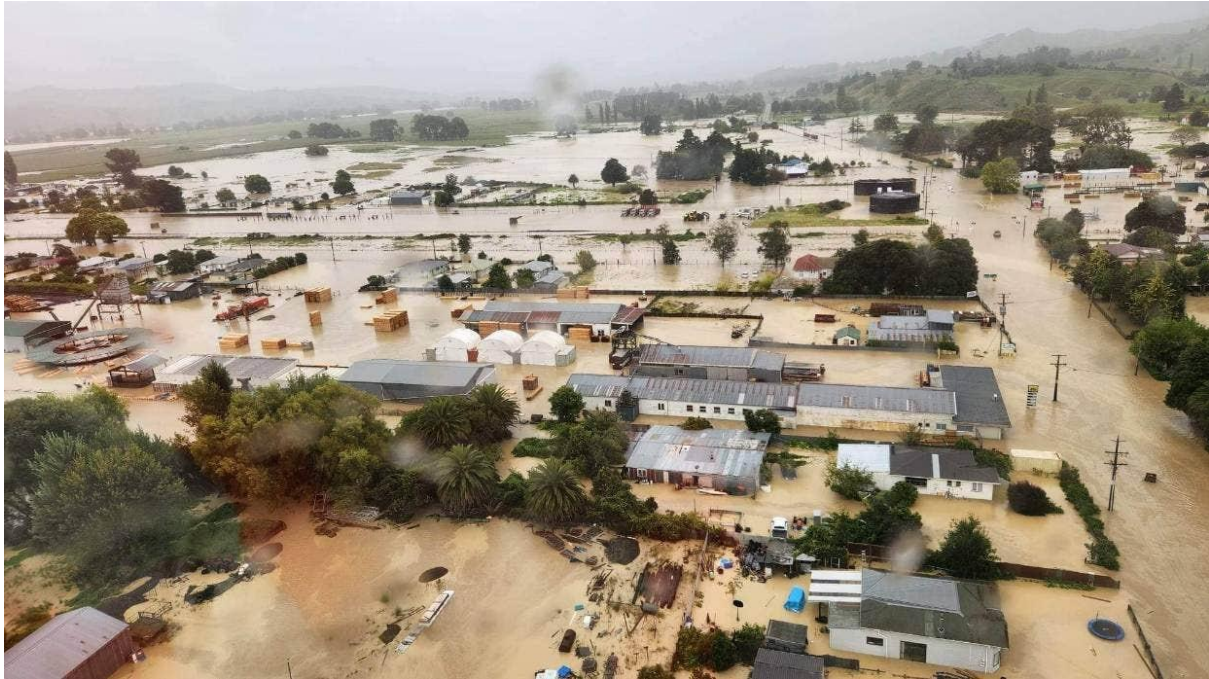
Figure 24. North Clyde - Cyclone Gabrielle

Cyclone Gabrielle's flooding of the North Clyde area of the Wairoa Township is the largest scale issue associated with this event. Flood waters drove the displacement of people from their homes and businesses. Taonga, including iconic marae such as Takitimu and Tawhiti a Maru Marae were placed at risk. Property damage was extensive due to the depth of flows and the deposition of significant volumes of silt. Other people and property were also severely affected in the Wairoa Campground, Awamate area, around and just above the rail bridge, and along the Wairoa River downstream of Marumaruru. These effects are still being felt today with people either displaced and/or living in temporary accommodation. Uncertain as to when, and under what conditions, permanent reoccupation of their homes will be allowed. Why did North Clyde Flood?

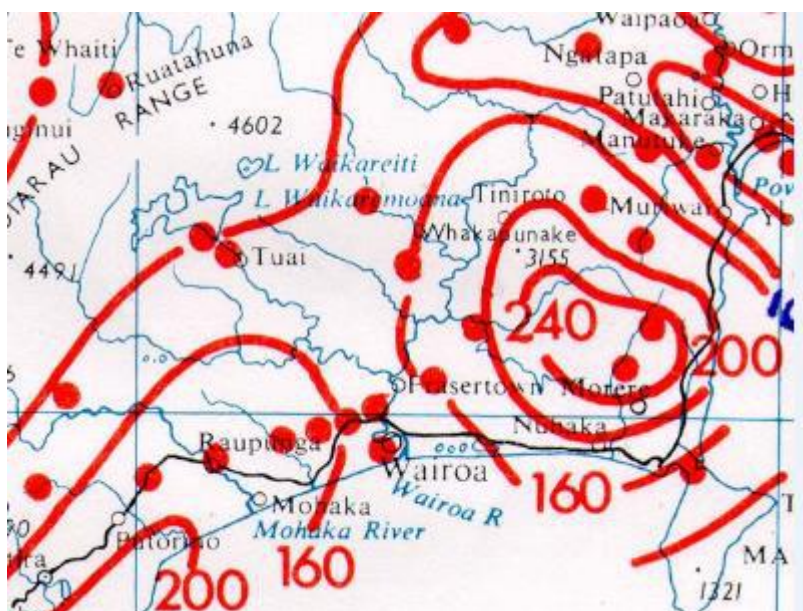
Figure 2. - Long-term average, 24-hour rainfall totals for a 5-year event

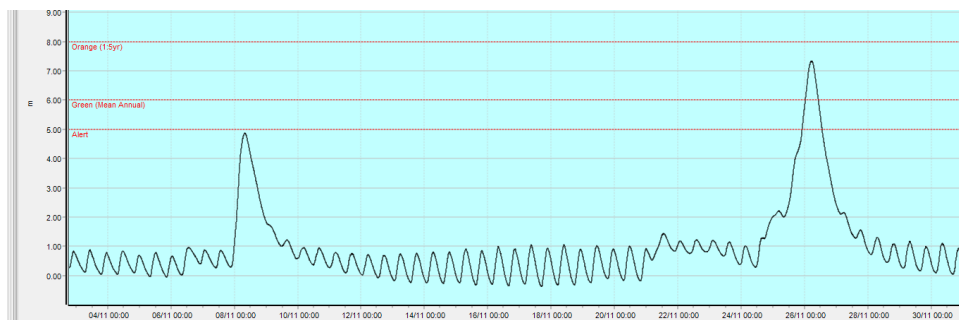
Figure 7.

influence of a tide at about 1m. Conclusion – at peak flow, there is zero influence from the tide at the railway bridge.
