What's happening with Wairoa's wastewater

WAIROA'S wastewater discharge consent upgrading to meet likely, more will expire in May 2019.

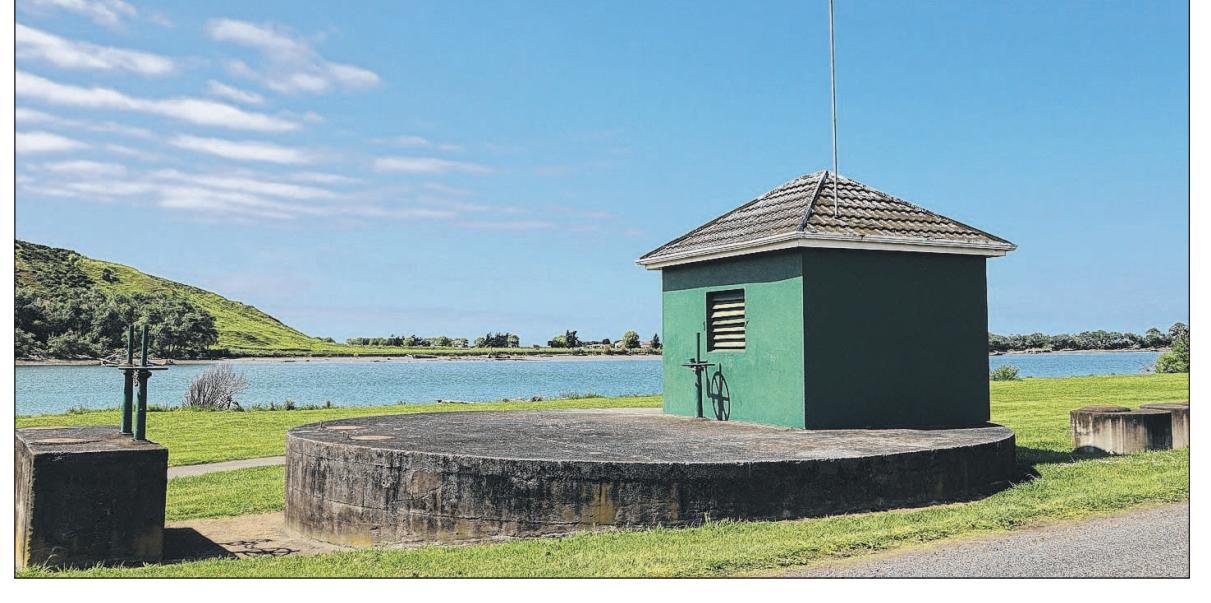
□ The large Kopu Road pump station.

There is a much larger station, located on Kopu Road, which is twice the size of the others and before the construction of the treatment plant in the 1980s it was the terminal station which discharged untreated effluent into the river opposite the station.

The Kopu Road station drains the rest of the town.

The effluent from Freyberg and Alexander Park was originally piped to Kopu Road, but after the completion of treatment this was discontinued and a new large diameter main was laid along Achilles Street and up Kitchener Street to the junction of McLean Street where it connected with another newly laid main from the Kopu Road station to direct all the town effluent to a new pumping station on Fitzroy Street where it is pumped up to the treatment plant on Pilot's Hill. All of these stations are
