# **Wairoa Wastewater Discharge Re-Consenting Summary of Wastewater and Stormwater Overflow Issues**

**Wairoa District Council**

October 2015

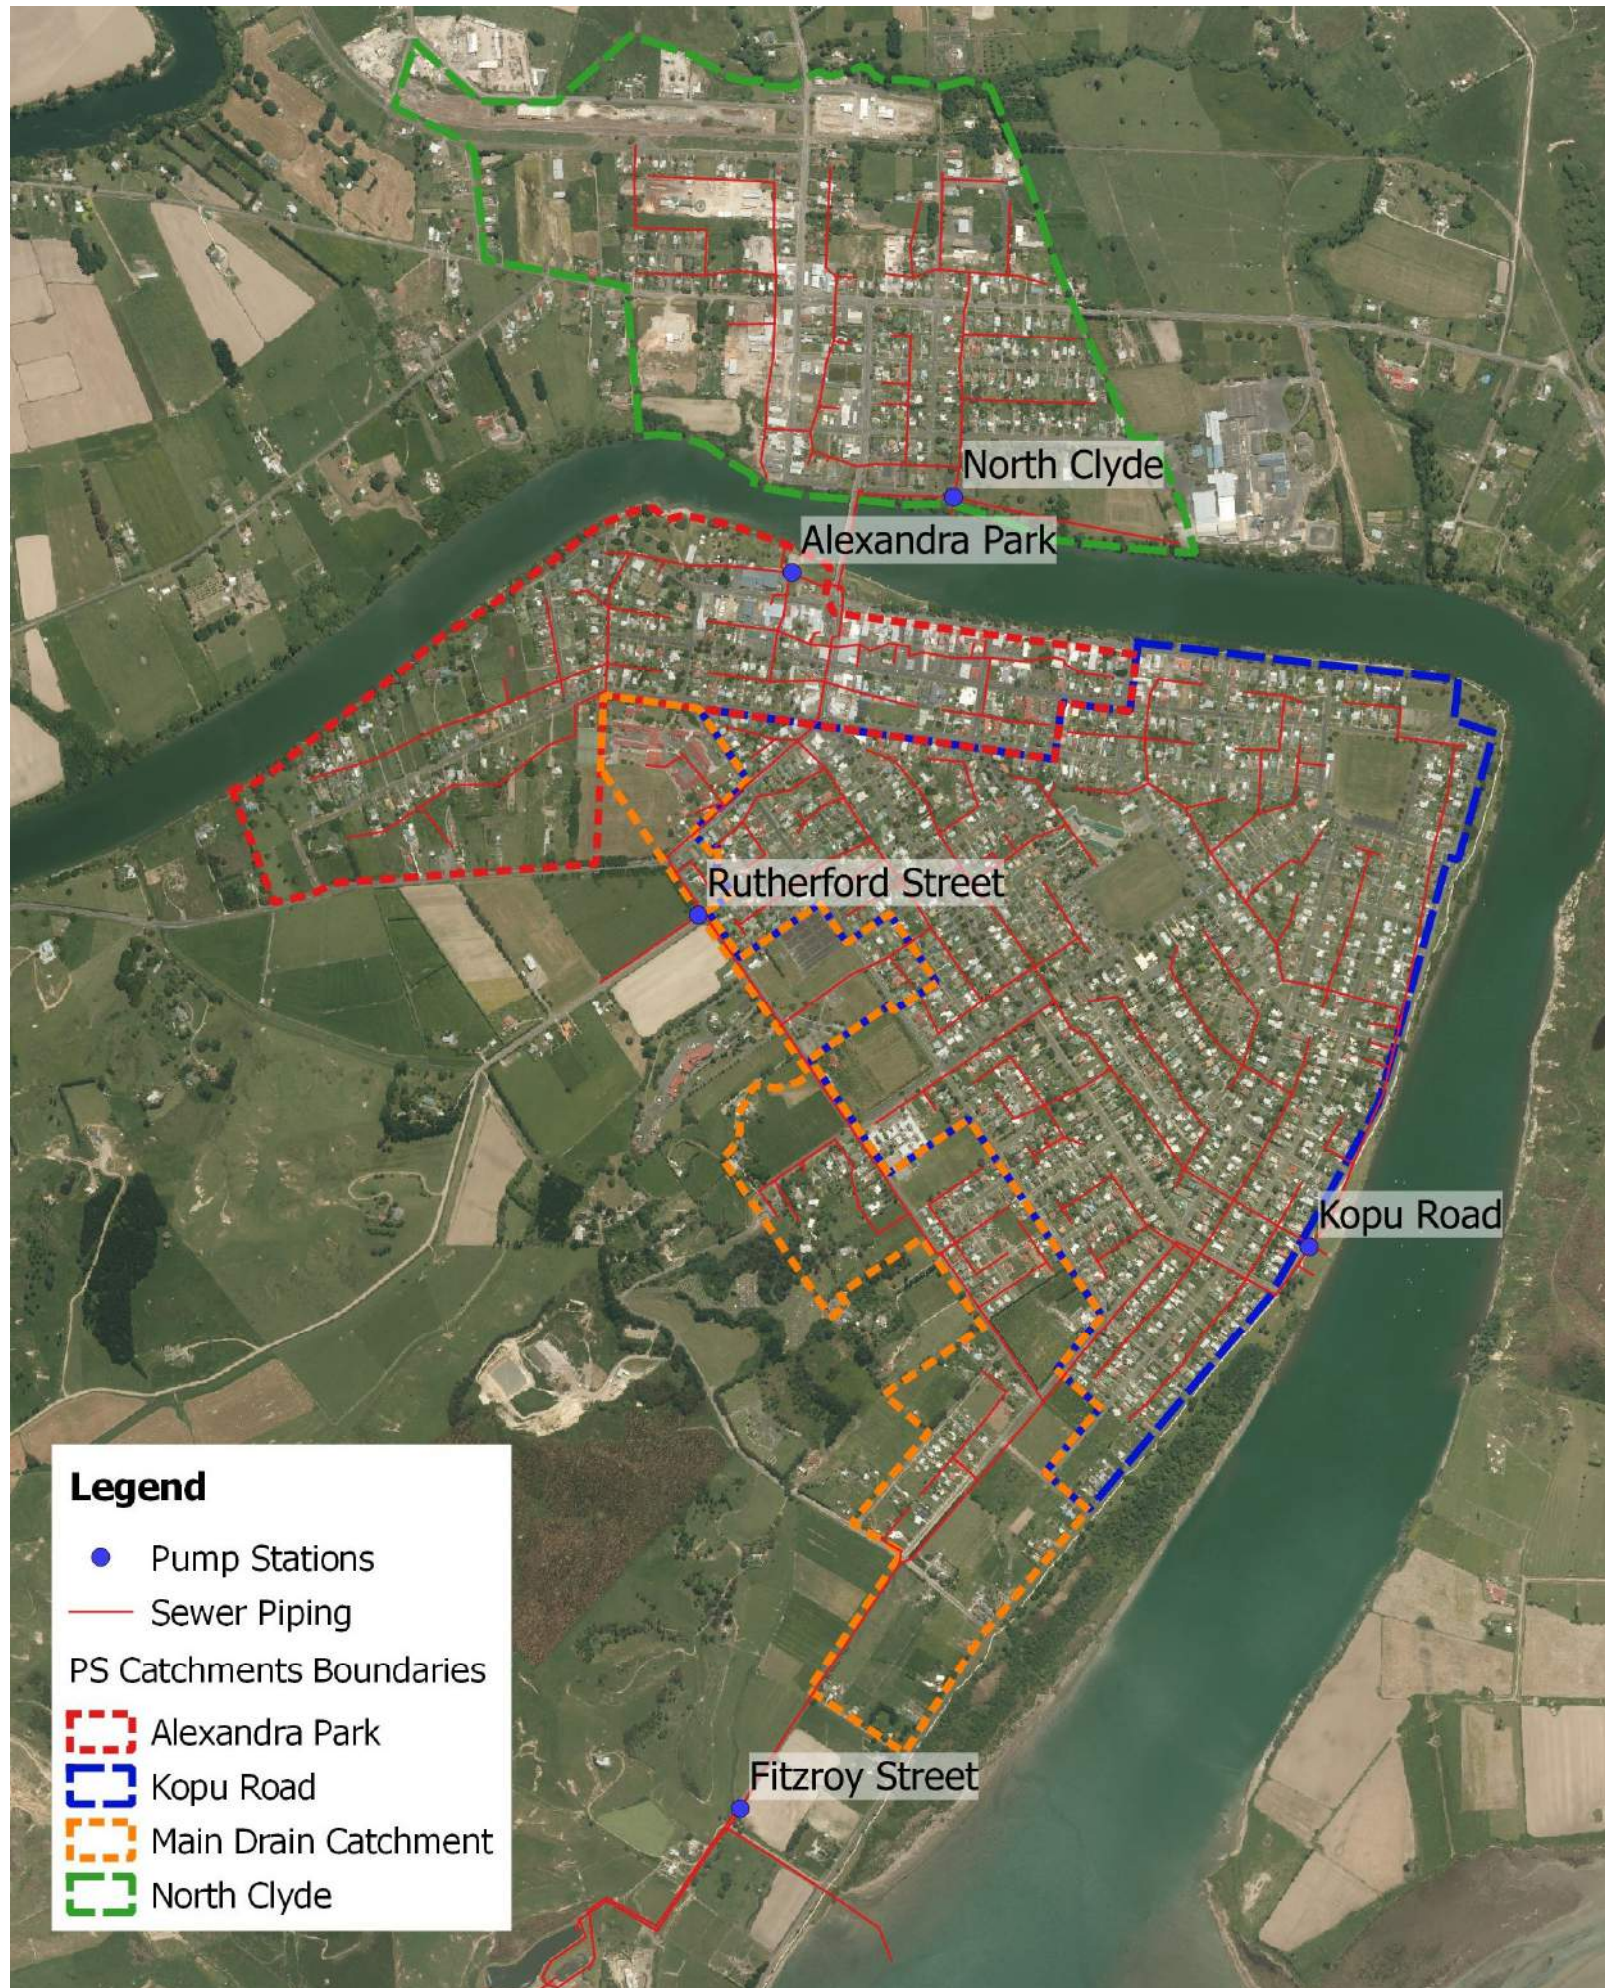
Figure 2: Sewer Catchments

Alexandra Park, North Clyde and Kopu Road are essentially lift stations, pumping the flow into a downgradient gravity sewer trunk main. Fitzroy Street is a main collector pump station that pumps the combined flows up a hill to the wastewater treatment plant. Further detail on the pump stations is provided in Opus (2012b). The sewer catchments are shown in Figure 2 in Appendix A.

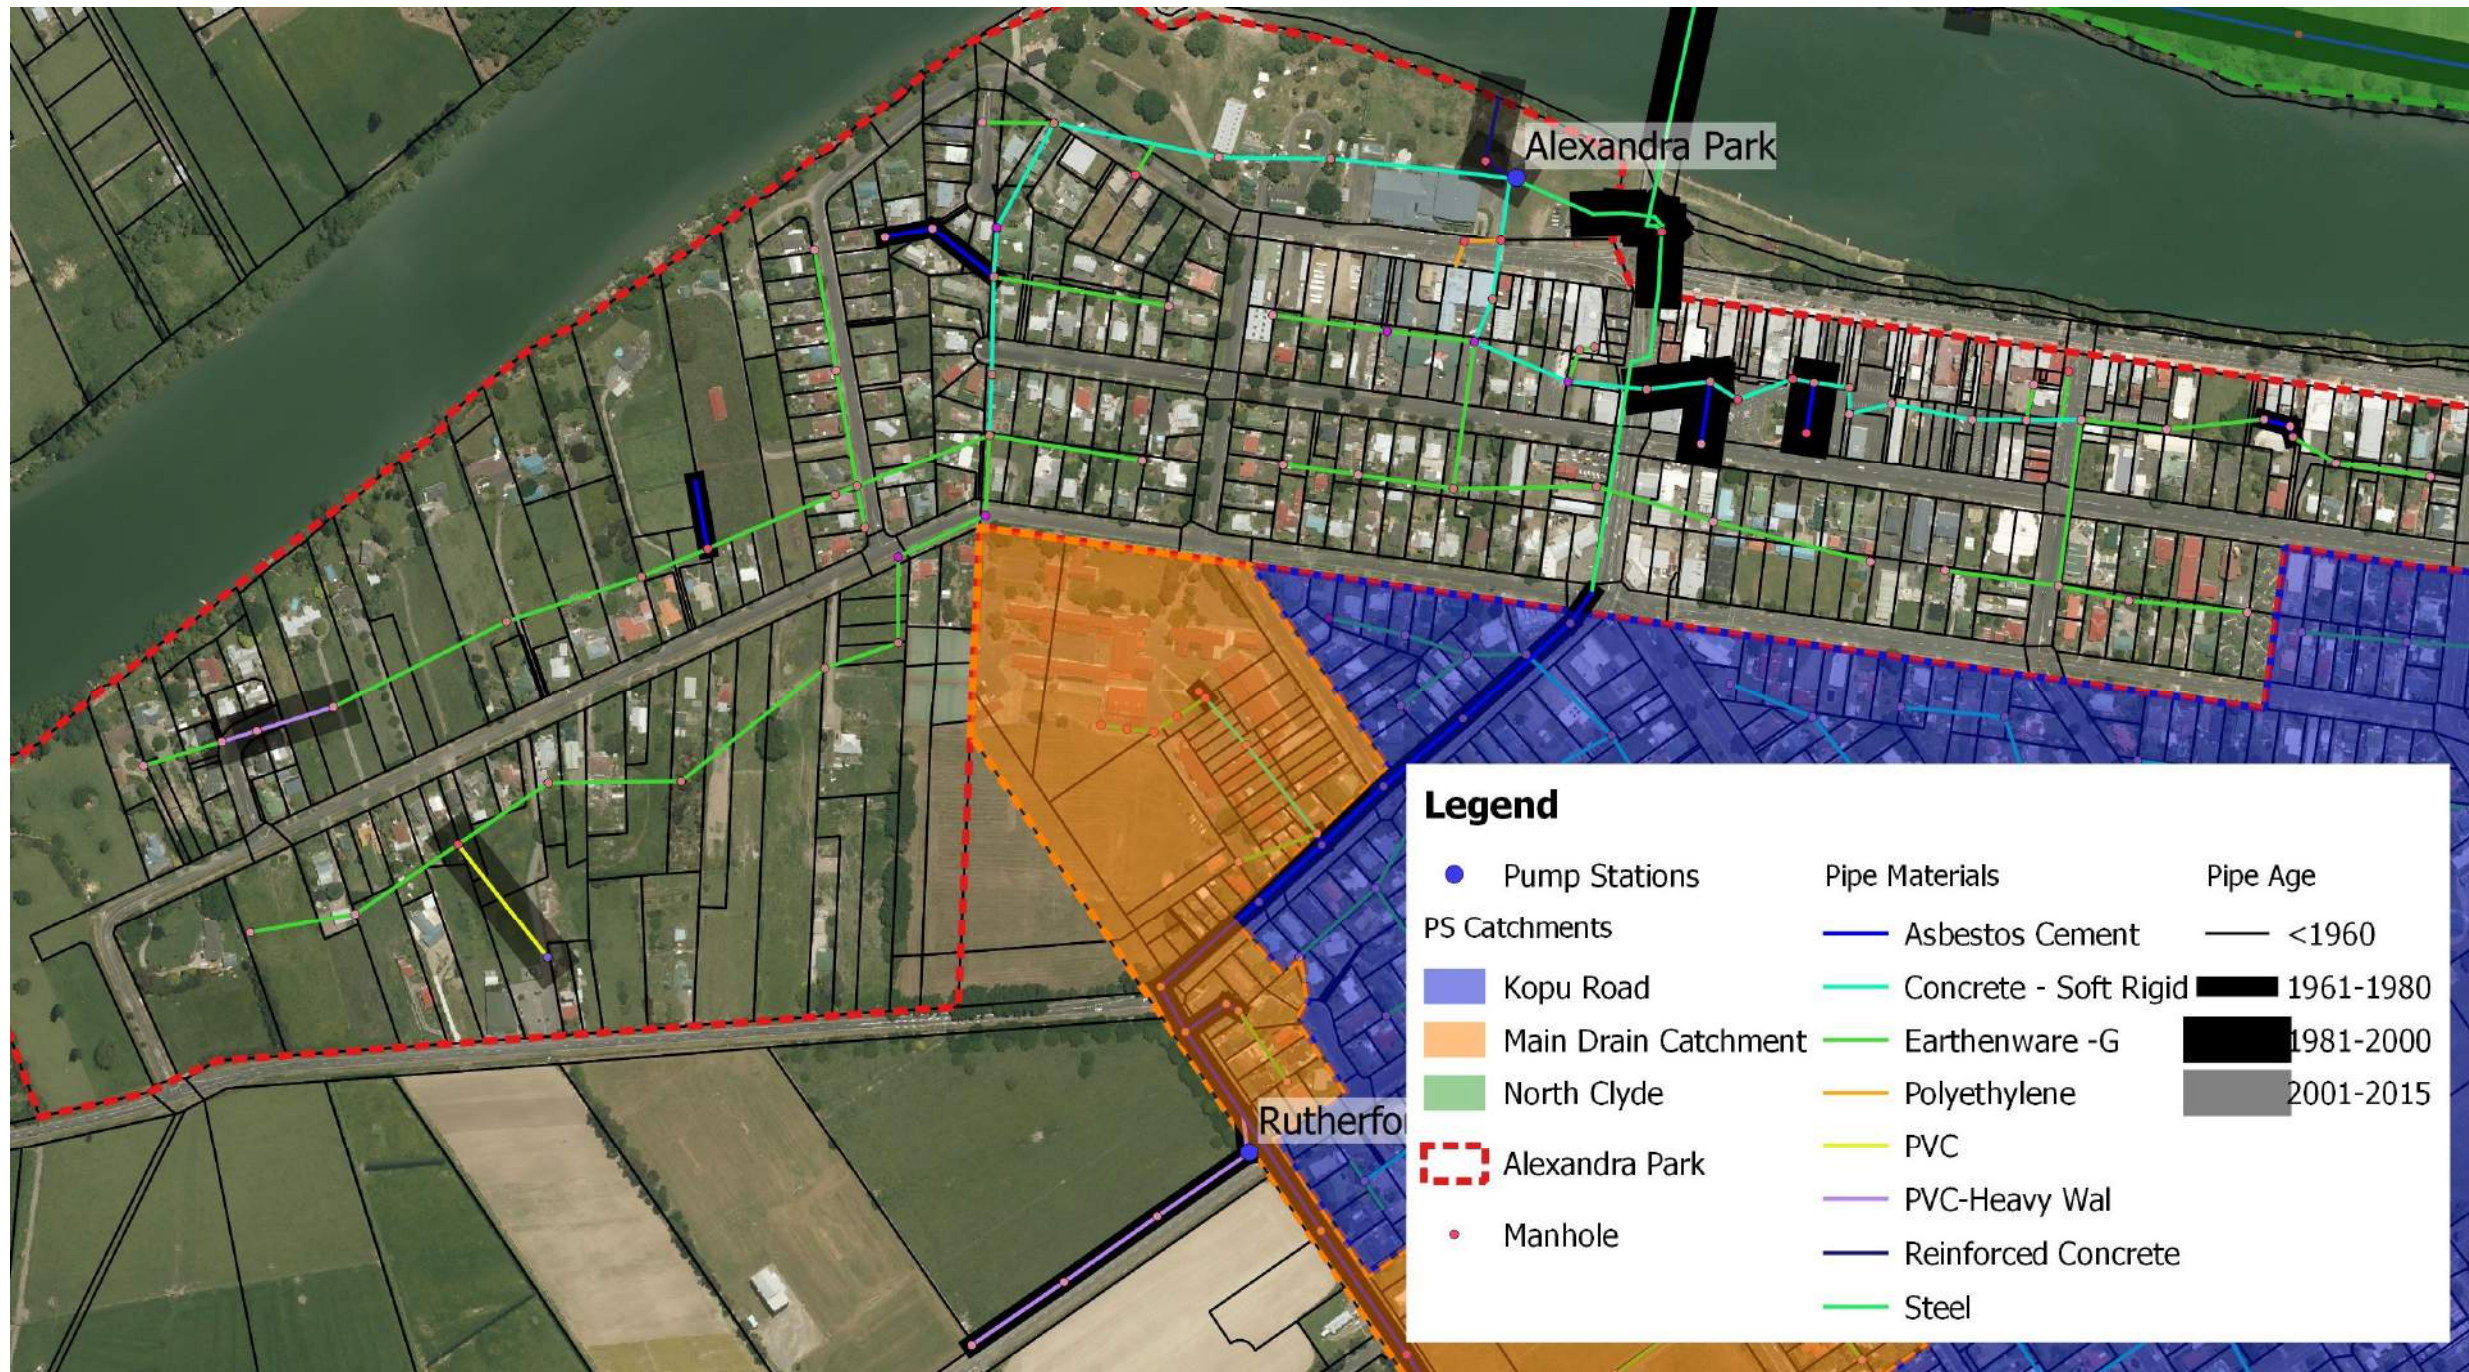
FILE NAME  
10292-WDC-A111-Fig4b\_Kopu\_Road\_Pipes

- Figure 3 shows an overview of the sewer catchments and the location of pump stations;
- Figure 4a shows the North Clyde catchment and the age and type of sewer piping material;
- Figure 4b shows the Kopu Road catchment and the age and type of sewer piping material;
- Figure 4c shows the Alexandra Park Catchment and the age and type of sewer piping material;
- Figure 4d shows the Main Drain catchment and the age and type of sewer piping material leading to the Fitzroy pump station;
- Figure 5 shows the sewer piping materials and diameters;
- Figure 6 shows observation and monitoring locations within the sewer network; and
- Figure 7 shows stormwater infrastructure and its location relative to the sewer network.
